**East Fork Little Miami River  
Watershed Action Plan**

# East Fork Lake Tributaries Watershed Management Plan

**September 2006**

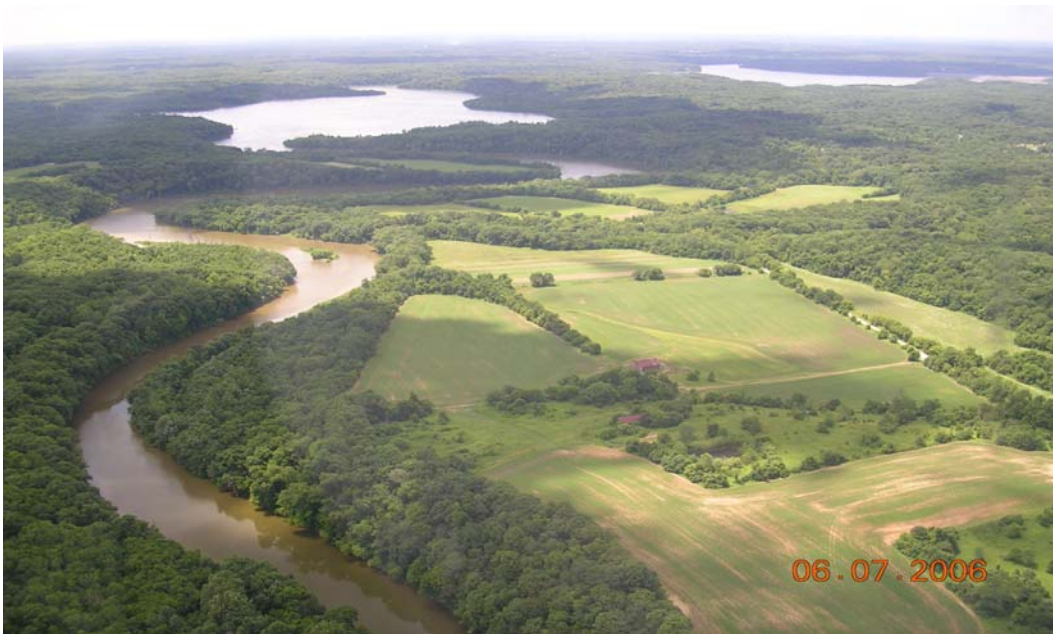
**Figure 2-16. Backwater section of the East Fork mainstem as it enters Harsha Lake. (Photo courtesy of Mike Miller)**

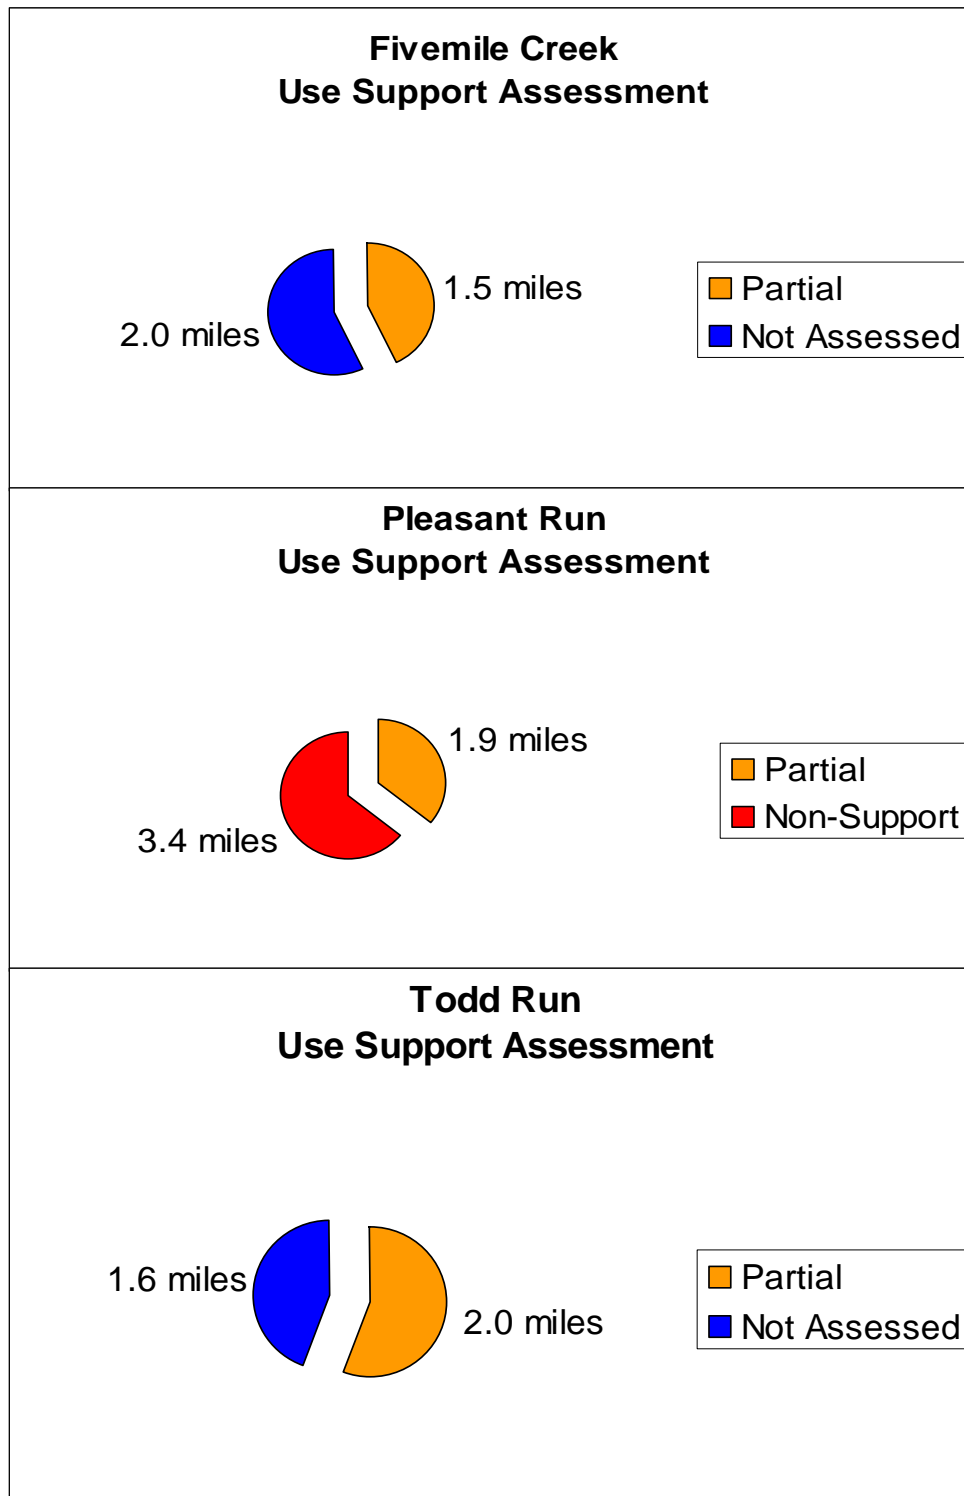
Of the tributary stream segments monitored by Ohio EPA in 1998, approximately 15 percent (4.0 miles) fully supported their aquatic life designated use, while 24 percent (6.3 miles) were rated "Full, but Threatened". Approximately 21 percent of the streams (5.4 miles) were in "Partial" support,

Figure 3.2 Use Attainment Support Assessment for Tributaries to EFLM River (WVH).

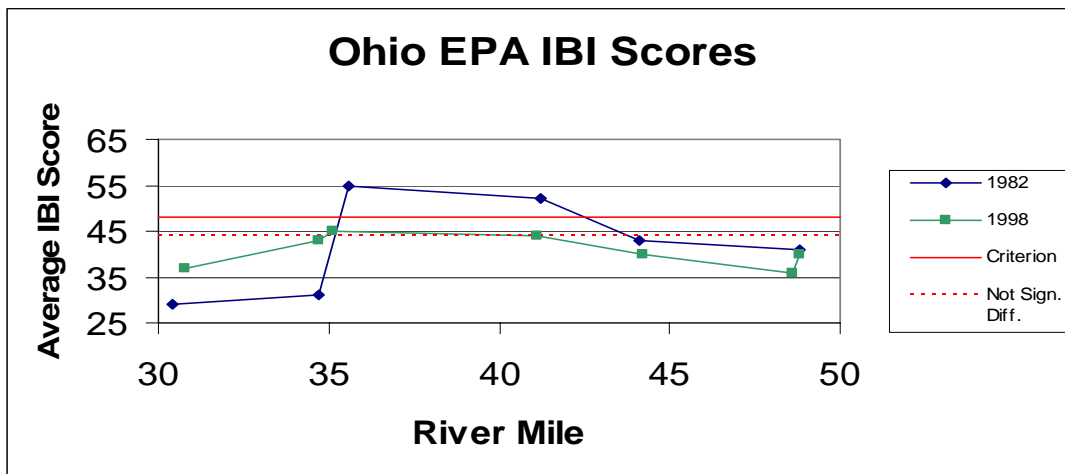
Fig. 3.4. Ohio EPA Index of Biotic Integrity (IBI) Scores, EFLM Lake Tributaries Sub-watershed (1982 and-1998).

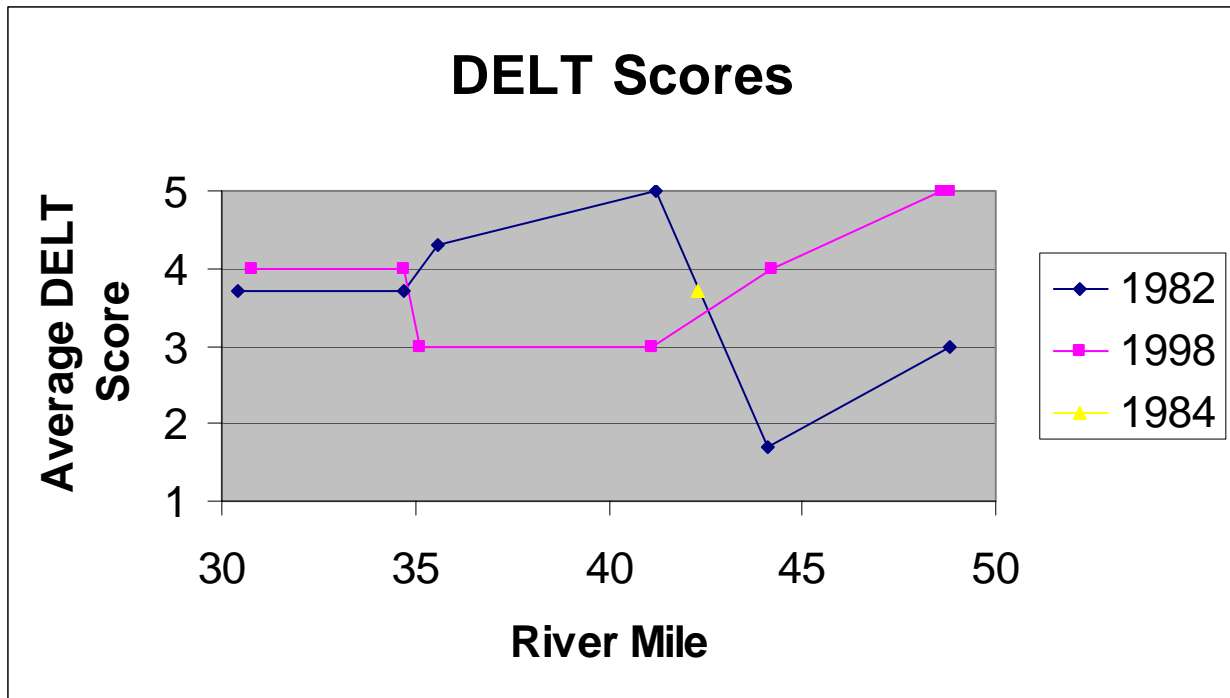
EWH criteria value of 46. The RM 41.0 site sampled in 1984 received a score of 48, exceeding the EWH criteria. All of the sites sampled in 1998 received scores that were either above or not significantly different than the EWH criteria value of 46 (Figure 3.7). This implies that overall water quality improved between 1982 and 1998. However, more recent ICI data from Clermont County for this section of the East Fork Little Miami River collected from 1996 through 2001

Fig. 3.6. Ohio EPA DELT Scores, EFLM Lake Tributaries Sub-watershed.

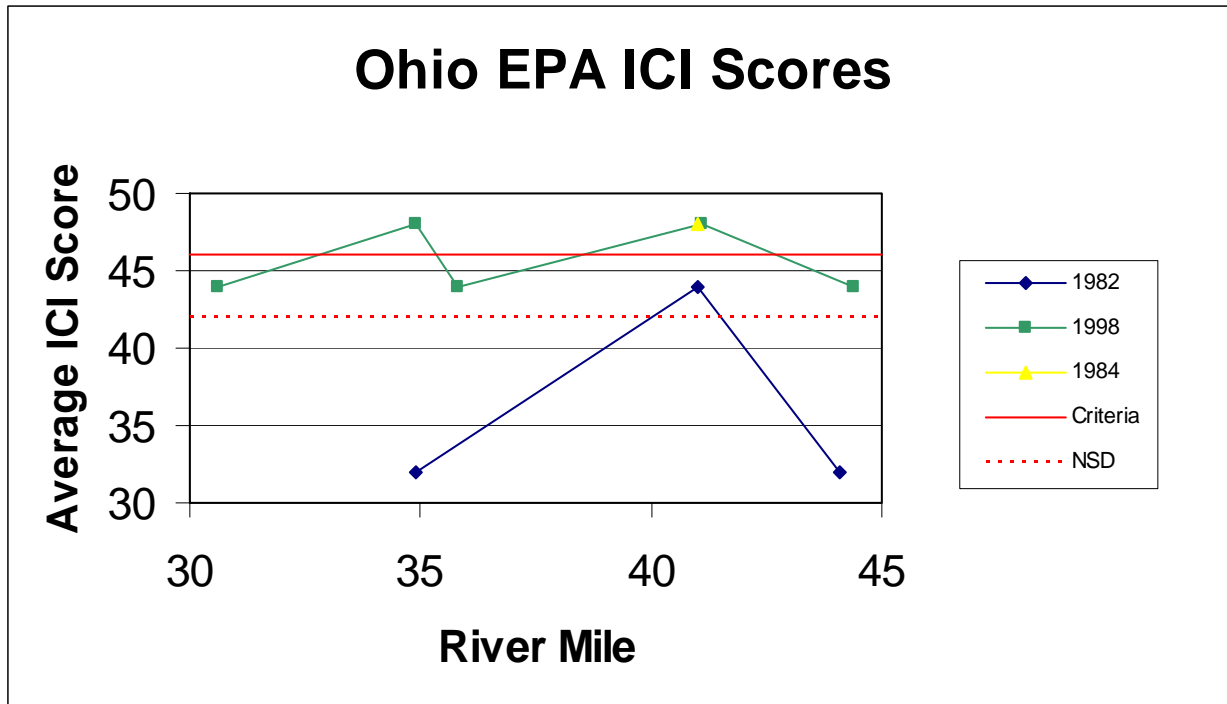
Fig. 3.7. Ohio EPA Invertebrate Community Index (ICI) Scores, EFLM Lake Tributaries Sub-watershed.

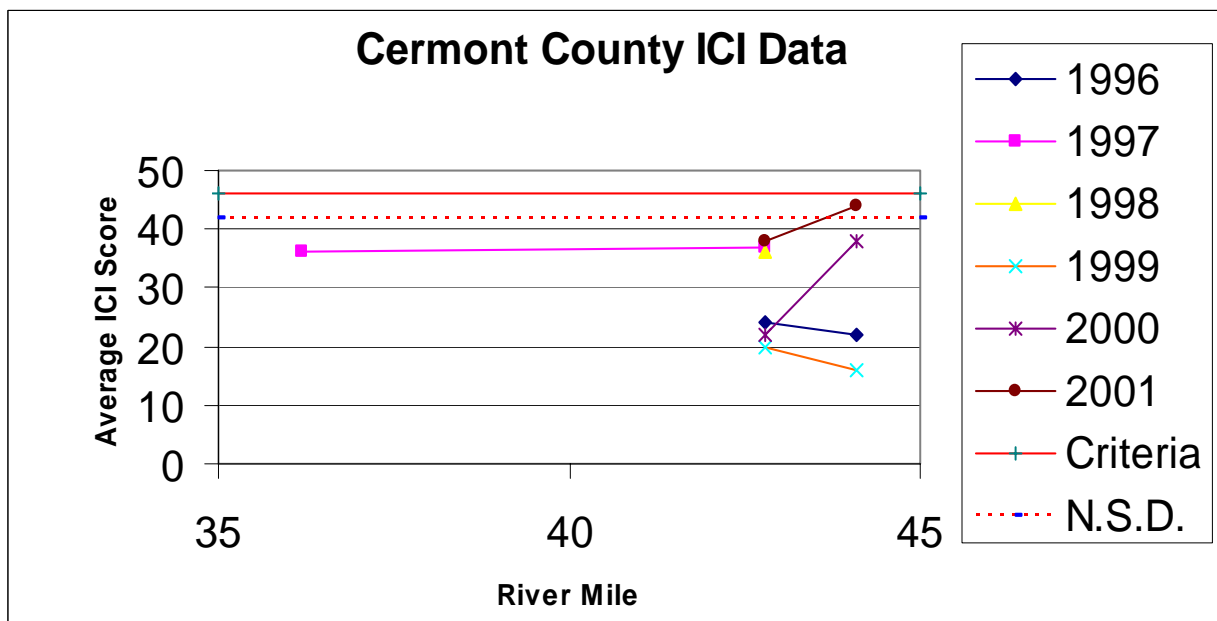
mer sampling. Also, low scores for 1997 may be attributable to extremely low flow conditions prior to and during the sampling period.

Fig. 3.8. Clermont County Invertebrate Community Index (ICI) Scores, EFLM Lake Tributaries Sub-watershed.

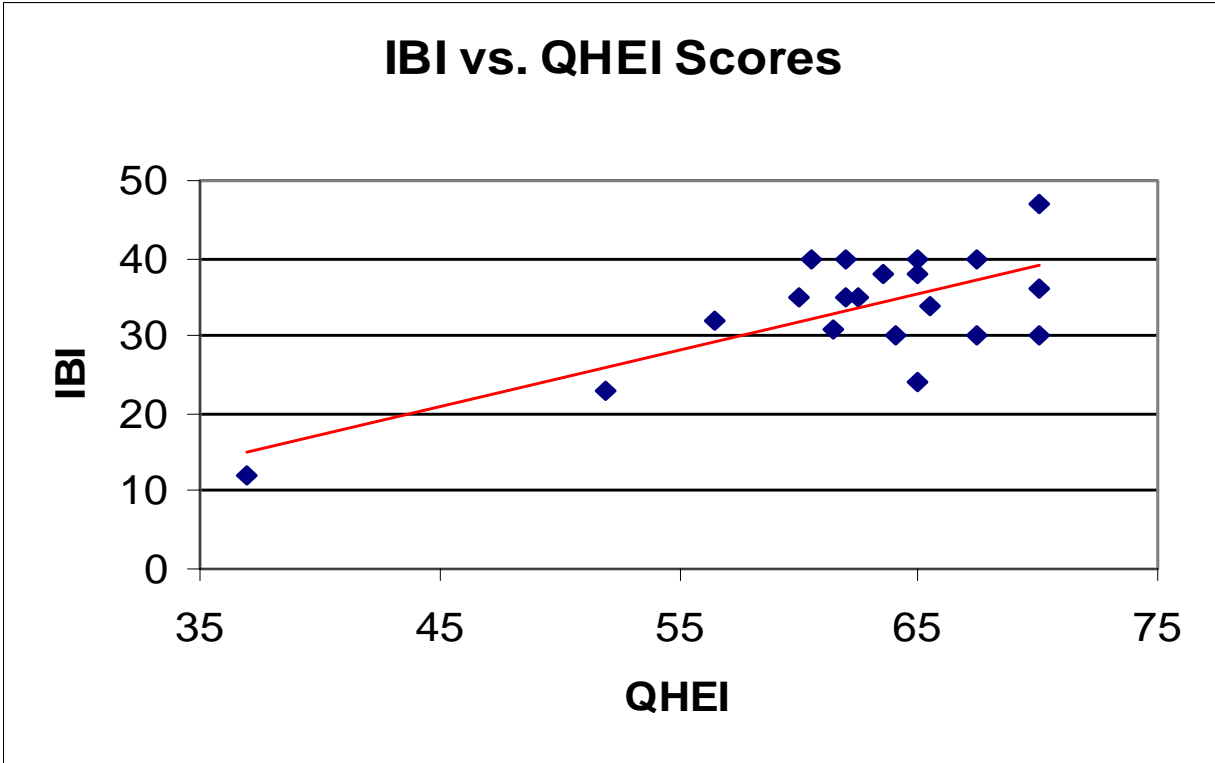
Fig. 3.9. IBI vs. QHEI Scores (OEPA and Clermont County Data).

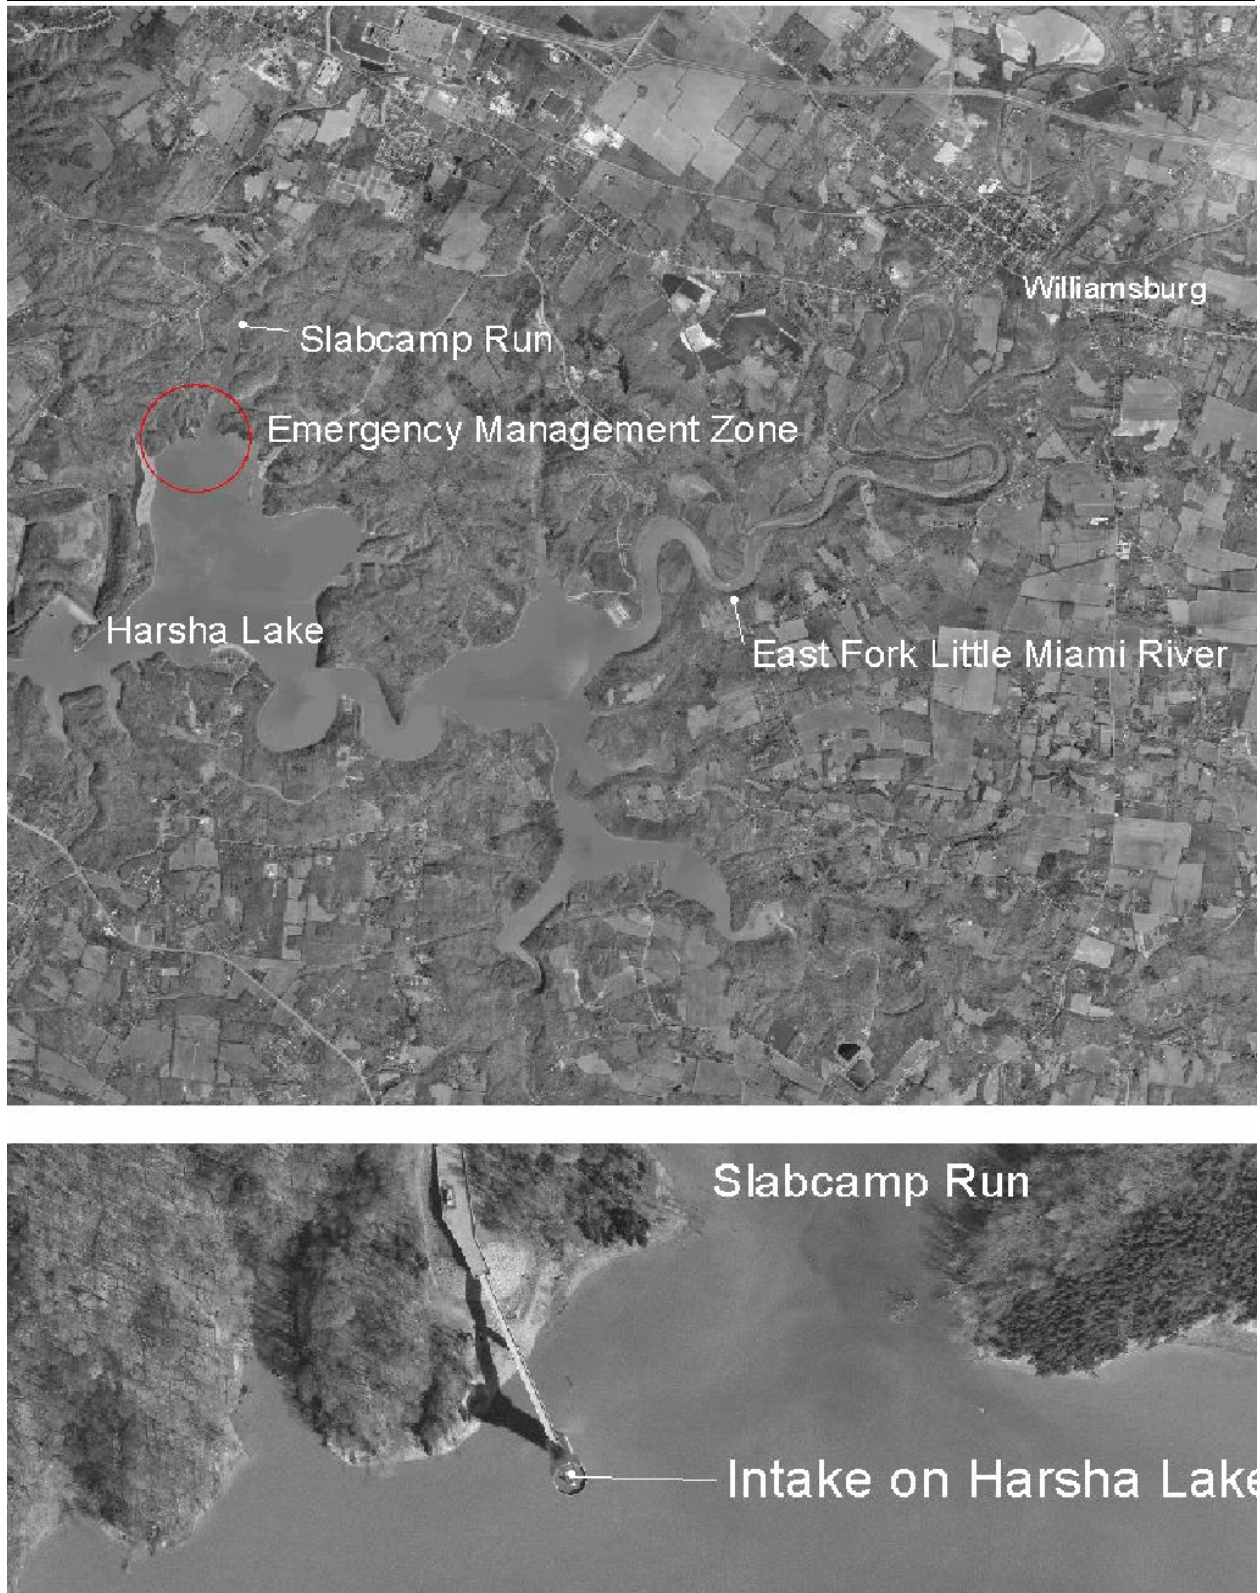
Figure 2: Emergency Management Zone for Intake on Harsha Lake.

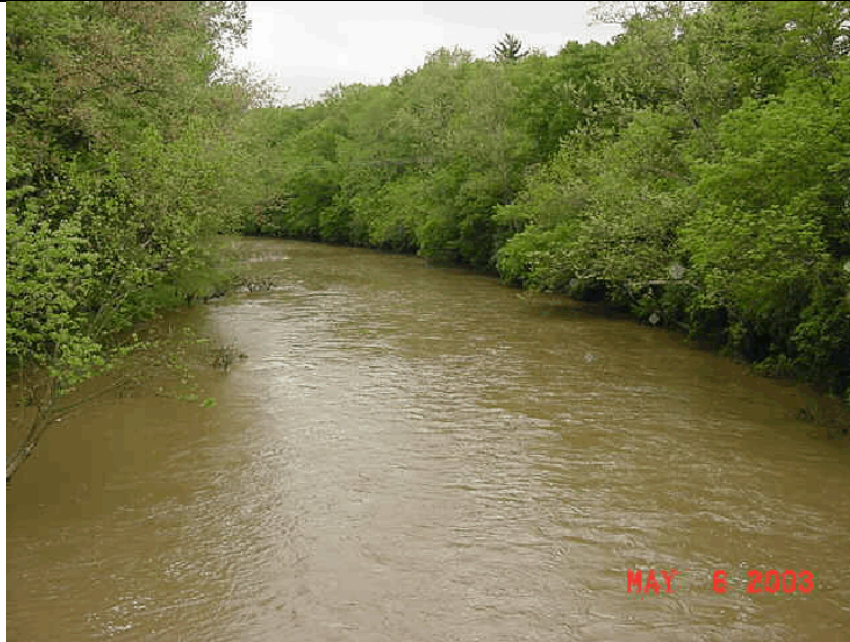
**East Fork Little Miami River RM 34.92 at SR 74 in Williamsburg**

Bacteria samples of surface water on May 6, 2003 in East Fork Little Miami River detected *E. Coli* at 950 colonies/ 100 ml and *fecal coliform* at 4500 colonies/ 100 ml. Both *E. Coli* and *fecal coliform* are above recreational criterion. *Fecal Streptococcus* was detected at 25000 colonies/ 100 ml. There is no criterion for *Fecal Streptococcus*. Failing home septic systems and animal

feed lots are suspected sources of bacterial contamination in the watershed.

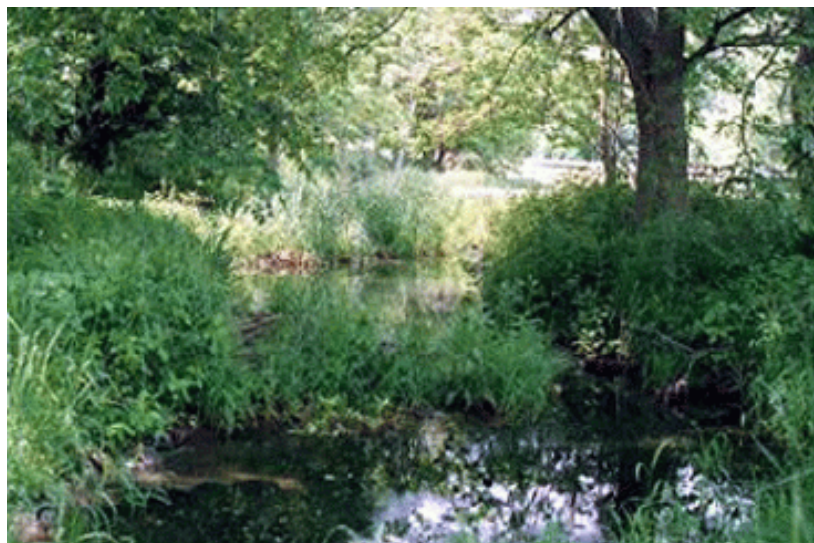
**Figure G-1: Guest Run Sampling Site.**

All of the streams in the Guest Run watershed were classified as B streams. B streams are moderately entrenched with a step-pool system and low sinuosity. The Rosgen Level II analysis determined that the stream at the sampling site was a B6c stream. This classification indicates that the dominant channel material was silt and clay, and the water surface slope was less than two percent. The low water surface slope indicates that this is an atypical B stream. It most likely has been entrenching due to changes in flow within the watershed. No chemistry or biology data were collected along Guest Run.

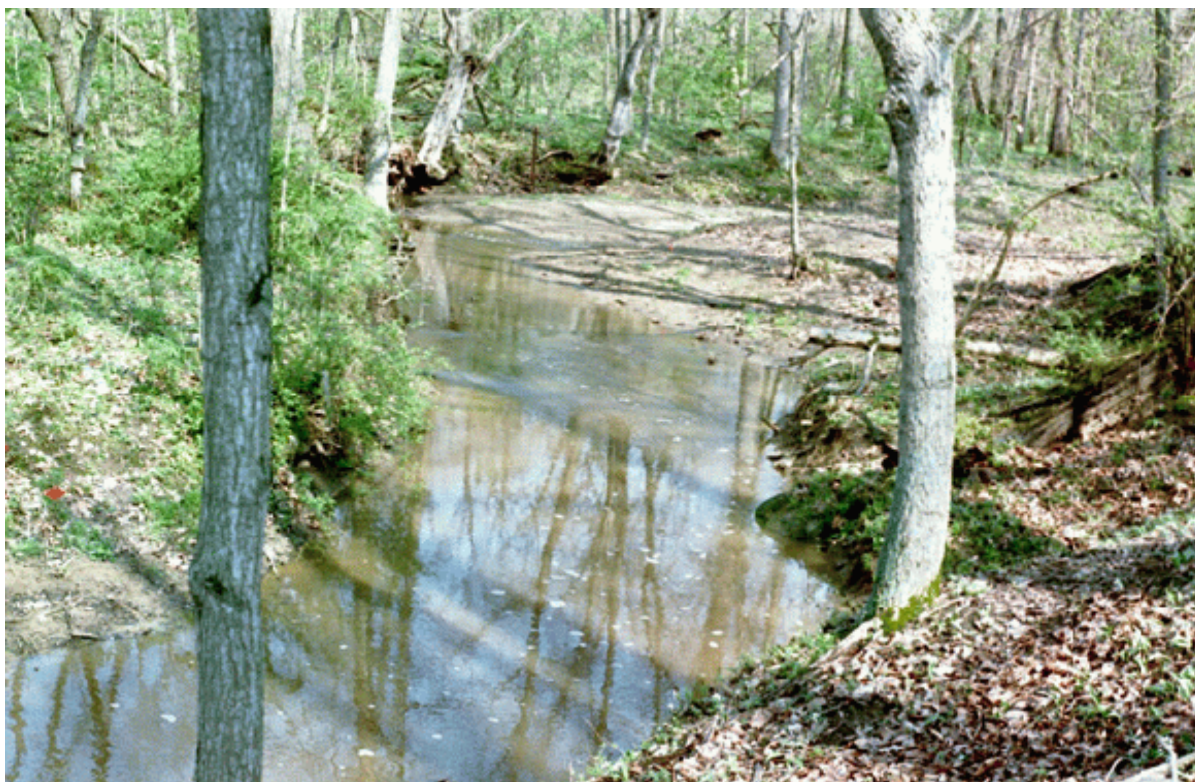
**Figure G-4: Crane Run Tributary Sampling Site.**

Most of the streams in this area were classified as C streams. The C stream is slightly entrenched, very sinuous, and has a riffle-pool morphology. Point bars and scour pools are characteristic in C streams. These streams are very sensitive to disturbance, especially in the riparian areas. At the sampling site, a C5 stream was observed. This stream had high sinuosity and a well developed floodplain. A predominantly sandy bottom was observed. No other biology or chemistry data were collected at this site.

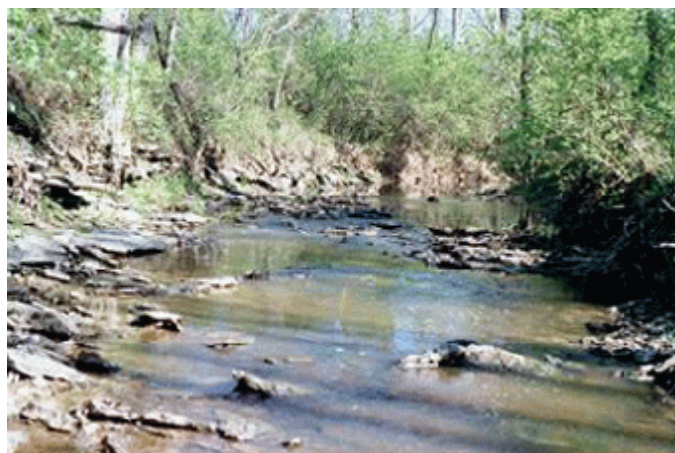
**Figure G-6: Kain Run Sampling Site.**

Water quality data (suspended solids, turbidity, and total volatile suspended solids) were relatively low and stable at the Kain Run ambient water quality sampling site. The automatic sampler at Kain Run detected significant increases in all three parameters during wet weather events in 2000. The five-year trend analysis showed that suspended solids concentrations were improving over the past five years (Tetra Tech, 2001a, 2001b).

Fish, invertebrates, and habitat were sampled at a site downstream of the water quality sampling site. Christian and Guttman (2000) and Grimm and Guttman (2000) showed that all three parameters were rated “good” at the Kain Run sampling site in 2000.

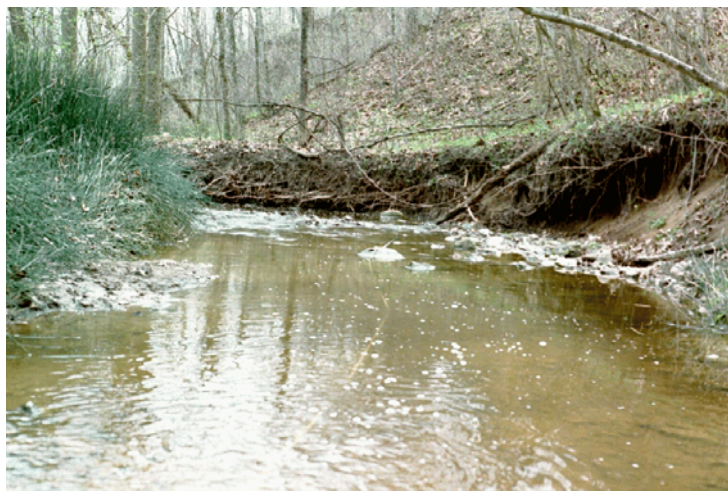
**Figure G-9: Erosional Feature at Cabin Run Sampling Site.**

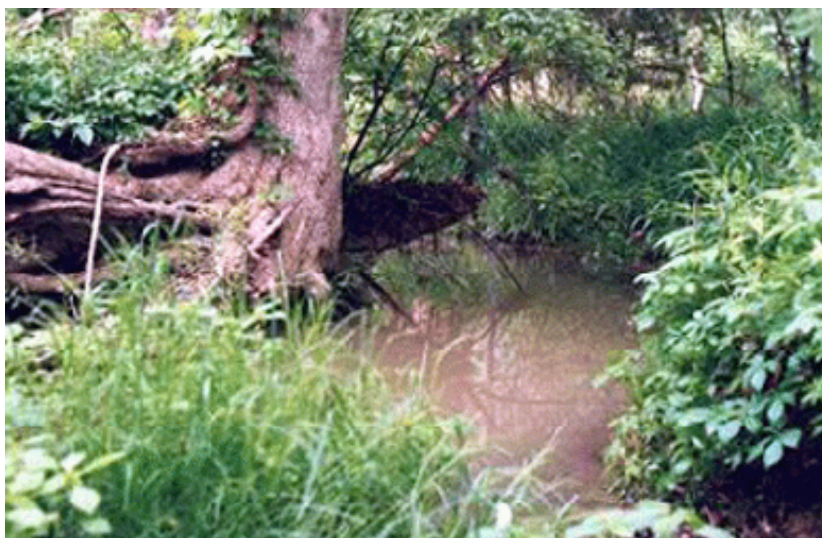
**Figure G-11: Cloverlick Tributary Sampling Site.**

Although Cloverlick Creek was classified as a C stream, this tributary was classified as an F stream. The stream was classified this way because of the high entrenchment and width to depth ratios found at the sampling site (Figure G-11). F streams are highly entrenched and have a riffle-pool system that is similar to C streams. These streams can have high erosion rates. The stream at the sampling site was classified as an F5 stream because of the predominately sandy bottom. The reason for the high entrenchment ratio at this site is unknown. It is possible that the entrenchment has been affected by new construction or agricultural practices in the area. Other watersheds draining urban areas (Hall Run, Shayler Run) were classified as F streams, however these watersheds had significant amounts of urban land. Chemistry and biology data were not collected in this watershed.
